UV LINING

UV Lining Sennybridge Brecon

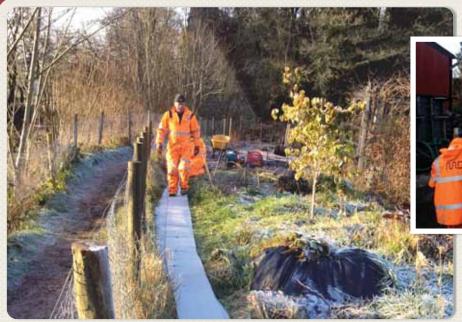
Pre CCTV and site visits showed that roots mass were present throughout the system causing high grade service

defects and structural issues with the existing pipe. Before work could commence the system was bunged off and monitored with our Jetvac. MDISS then engaged the use of it's 32t recycler to root cut the roots mass using its specialized chain cutters. Any larger tap roots were cut off using our robotic cutter. Each line was then surveyed and the liners winched in and cured using UV Light.

Due to the difficult access MDISS was unable to get vehicles to the required Manholes. A 3.5t winch was placed in position using our off road vehicles and the liners hand carried to the required assets.

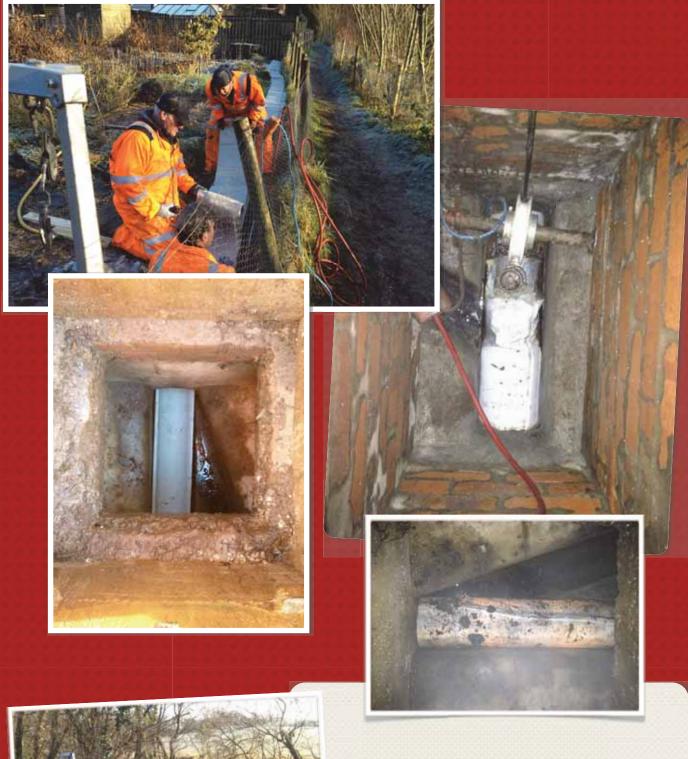
SENNY BRIDGE PHOTOS

LINER BEING WINCHED IN

LINERS BEING FED IN

LIGHT TRAIN CURING LINER
