# UV LINING

LEWIS CIVIL ENGINEERING  
ENGAGE MDISS TO COMPLETE UV  
LINING AT SENNYBRIDGE BRECON

## UV Lining Sennybridge Brecon

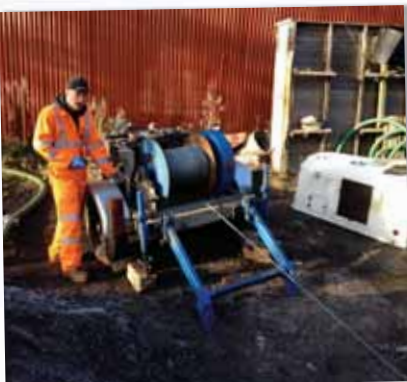
LINER BEING WINCHED IN

defects and structural issues with the existing pipe. Before work could commence the system was bunged off and monitored with our Jetvac. MDISS then engaged the use of it's 32t recycler to root cut the roots mass using its specialized chain cutters. Any larger tap roots were cut off using our robotic cutter. Each line was then surveyed and the liners winched in and cured using UV Light.

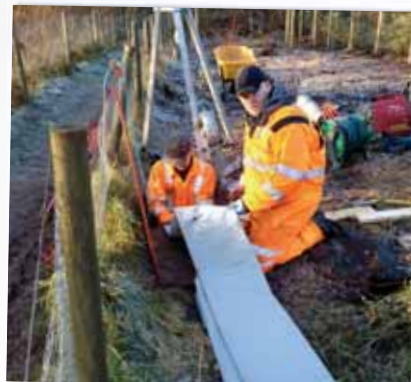
LINERS BEING FED IN

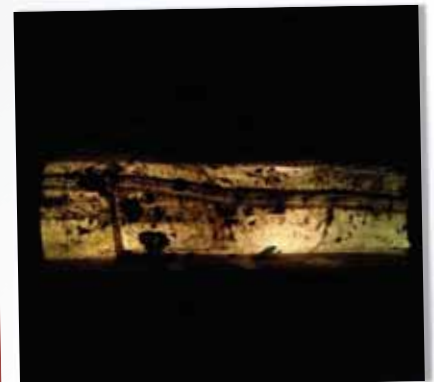
LIGHT TRAIN CURING LINER
