No Compromise
When It Comes to
The Cost Effective
Renewal Of Drainage
Pipes

Hanger Lane Robotic Cutting

Vinci Construction Ltd
Hanger Lane Bridge Replacement
Ealing, London, W5 2ED

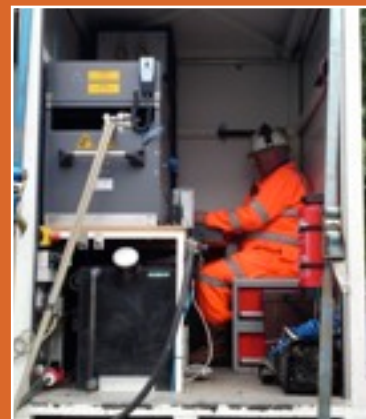
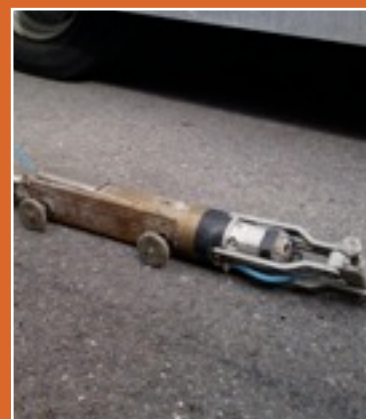
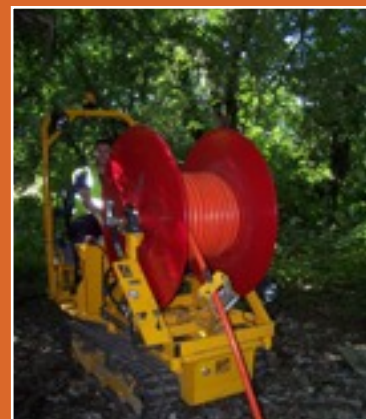
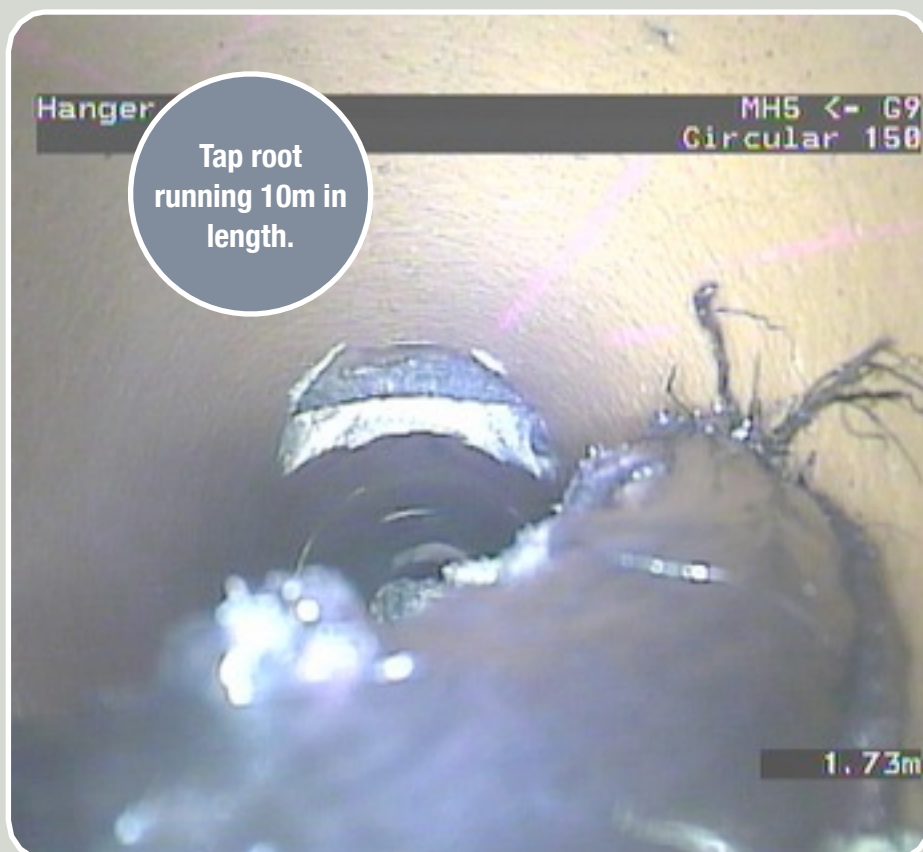
ROBOTIC CUTTING

Post de-silt CCTV revealed that all the siltation had been removed however it also revealed that mass and tap roots were growing throughout the system.

Left: Roots within Pipe
Top: Operating Cutting Rig
Middle: Robotic Cutter
Bottom: Off Road Reel.

MDISS quickly deployed their Prokasro 4.0 Robot to cut out the roots.

As this robot is able to cut with full movement in pipe sizes down to 130 mm it quickly and effortlessly removed the roots from the system to enable the following Ultra Violet pipe line rehabilitation works to be carried out.

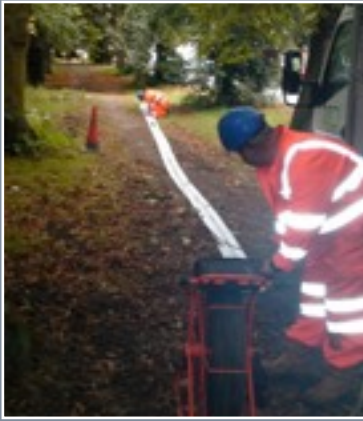
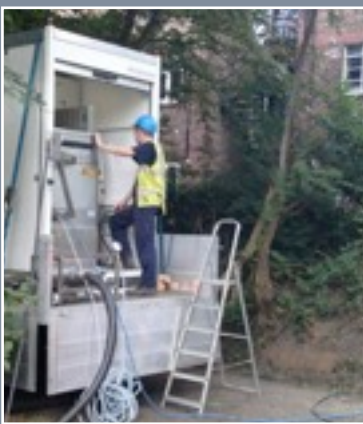
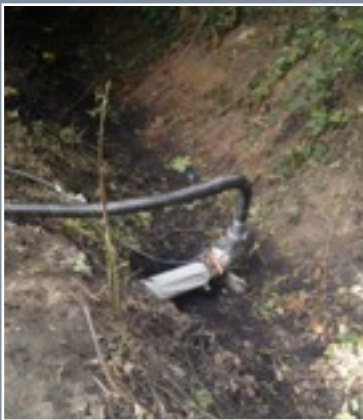
MDISS UV Lining

TOP; UV Liner Setting Up.
Middle; UV Pod
Bottom; Inserted UV Liner
Right; UV Control Panel

To prevent re-growth of the roots MDISS recommended the installation of glass fibre reinforced structural liners.

Based on this guarantee and the proven track record of MDISS the instruction was given to proceed with the installation of the liners and to cure with **Ultra Violet Light**.

The UV Liners are glass fibre pre-impregnated liners with a quality that is second to none.
